# Ergonomics

Good Practice in the Irish Workplace

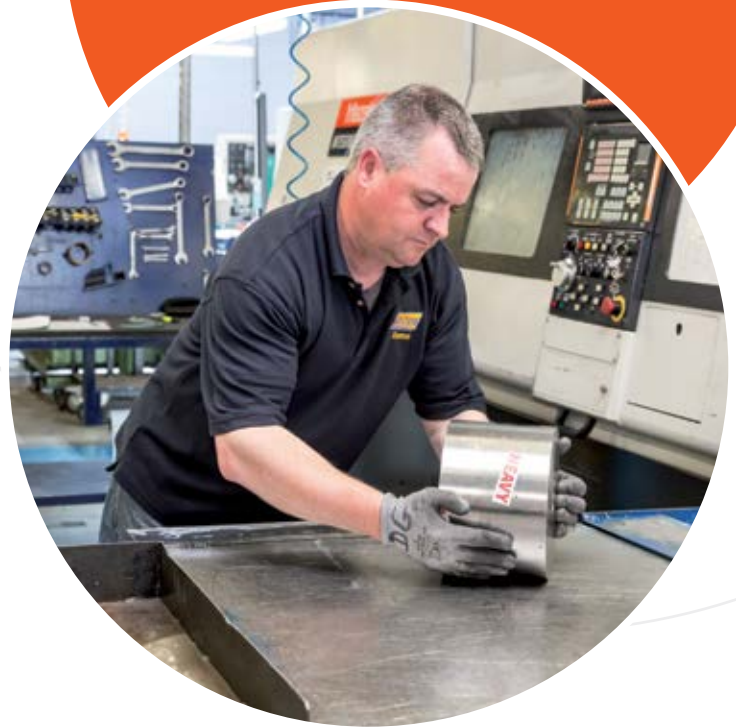
Before: Operator manually lifts the billet from the staging table

The specific task relates to the edge-welded metal bellows seals, which are mainly found in pumps and compressors, and prevent the medium being driven from leaking into the outside world. The current Case Study is focused on the loading of metal billets into the CNC machine. Previous to ergonomic risk management, the undrilled metal billets were brought on a workshop trolley to be loaded into CNC machine. The billet was then transferred manually from the trolley to the stage table, to accommodate the difference in height from trolley to table. It was then manually lifted from the table into the CNC machine.

The assessment highlighted an unacceptable risk of back injury when lifting, reaching, loading and unloading the metal billets which can weigh 20-130kg.

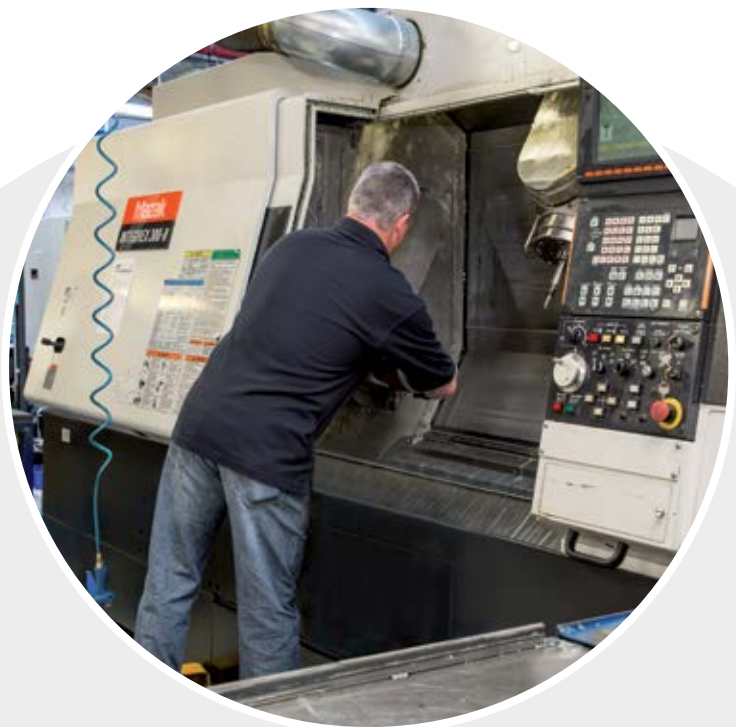
Before: Operator manually transfers the billet into the CNC machine

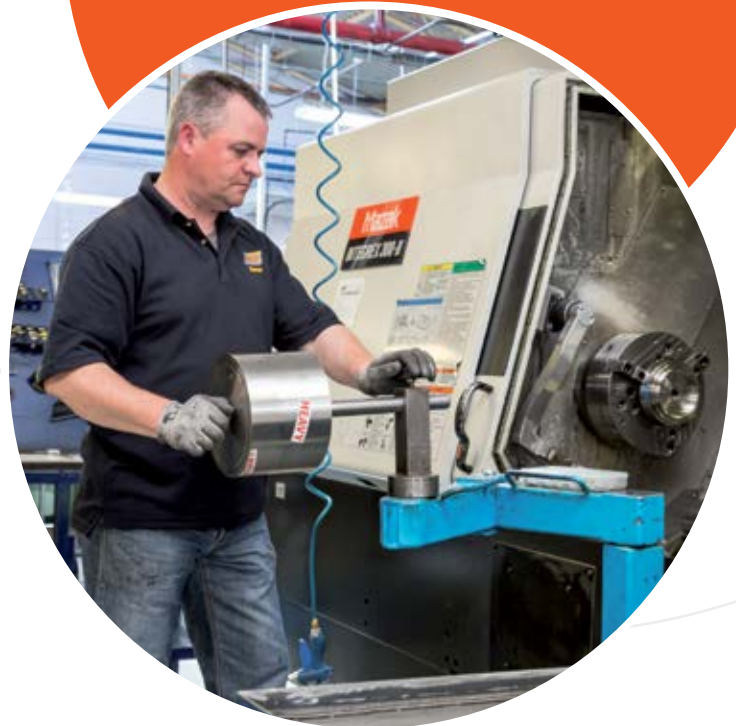
After: Operator uses custom engineered billet loader to transfer billet to CNC machine

Conventional gantry style lifting devices could not be used because of overhead restrictions, so a floor based articulated arm was developed. The primary concept was developed in-house by the Maintenance department in conjunction with the machine operators and Environmental Health & Safety (EHS). Additional refinements were subsequently added by the fabricator.

A custom engineered billet loader was fixed to the floor at each CNC machine centre, and all operators were trained to use it. The units were added to the preventive maintenance system for periodic integrity check.

The Purchasing Department arranged for the material vendor to supply any billets over 6 inches in diameter with a 1 inch hole drilled into the centre. This is to facilitate pick-up by the prong on the billet loader.

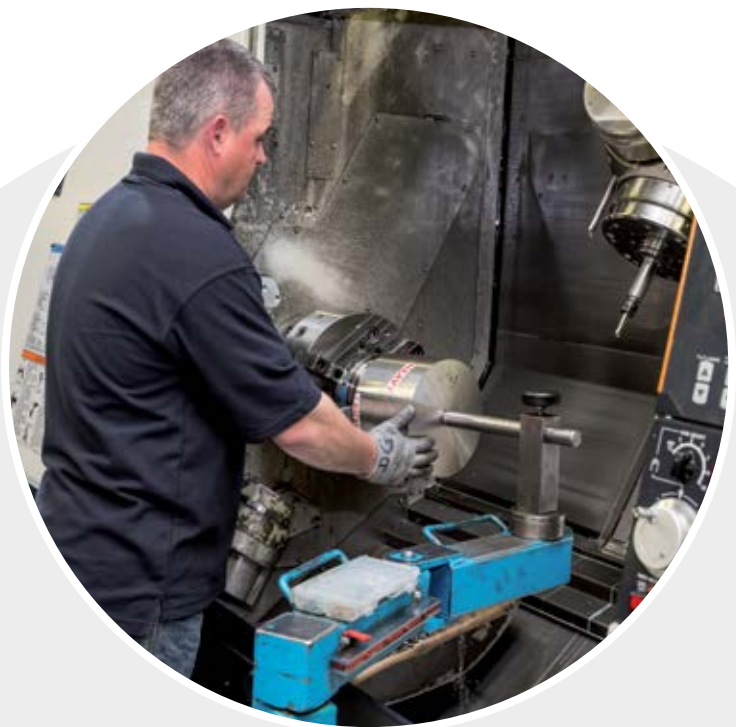
After: Operator uses custom engineered billet loader to transfer billet to CNC machine

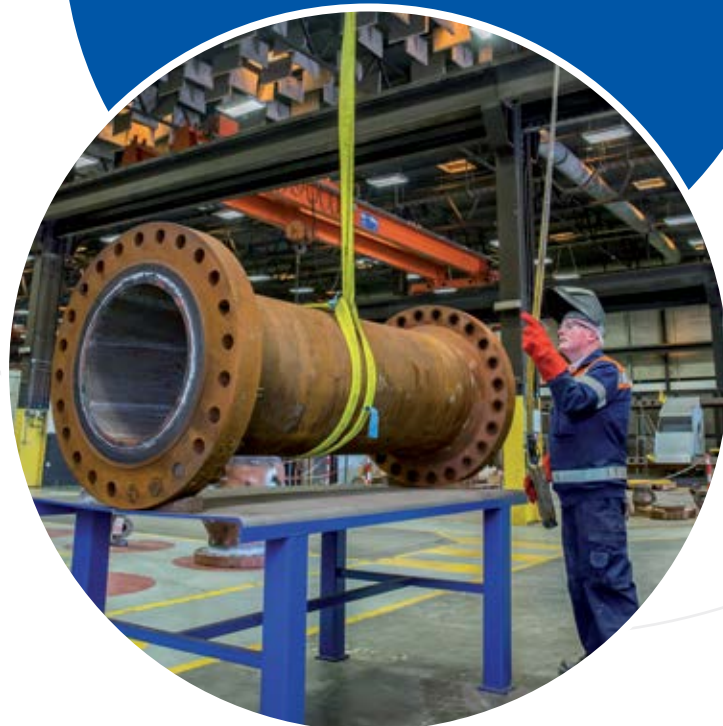
Before: The Operator rotates pipe using an overhead hoist

In the Central Workshops, pipes with wall thickness of 2" and up to 30" diameter need welding. In the current system the pipe rests on a bench or stand and has to be lifted with slings to rotate it to the next working positions. This requires as many as 64 interruptions to welding to allow the pipe to be rotated. This is to ensure that the section being welded is in the correct position. Even so, the welder is often in an awkward position – especially on the larger pipes.

The current system led to a sustained awkward posture for welders when welding pipes up to 30" diameter. Two welders had to change position repeatedly to weld the circumference of the pipe. The pipe had to then be turned numerous times, often as many as 64 rotations within a 3 day period. The welders were required to crouch, and risked burn injuries when working below the weld and also had to lean across the top of the pipes.

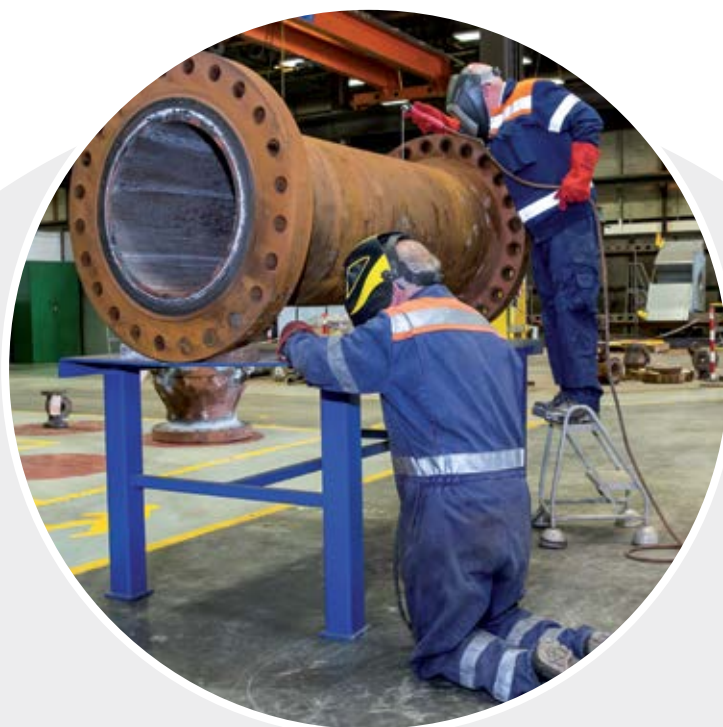
Before: Operators carrying out welding work while maintaining awkward positions

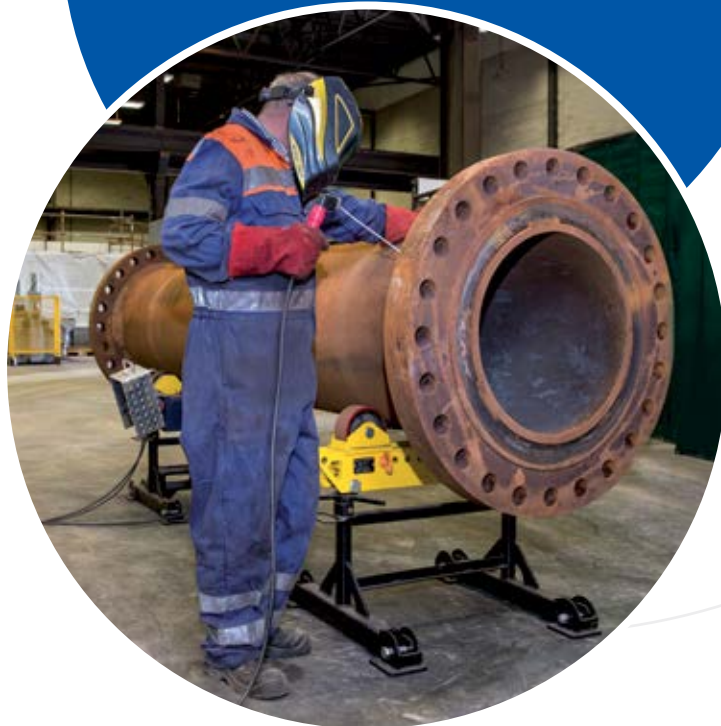
After: Rollers in position to allow operator maintain good posture while welding pipe

The agreed changes were to utilise equipment (rollers) that were used for other purposes in the CWS. The rollers have:

- Adjustable wheel spacing to suit different pipe diameters
- Adjustable height
- One stand is motorized so that the pipe can be turned

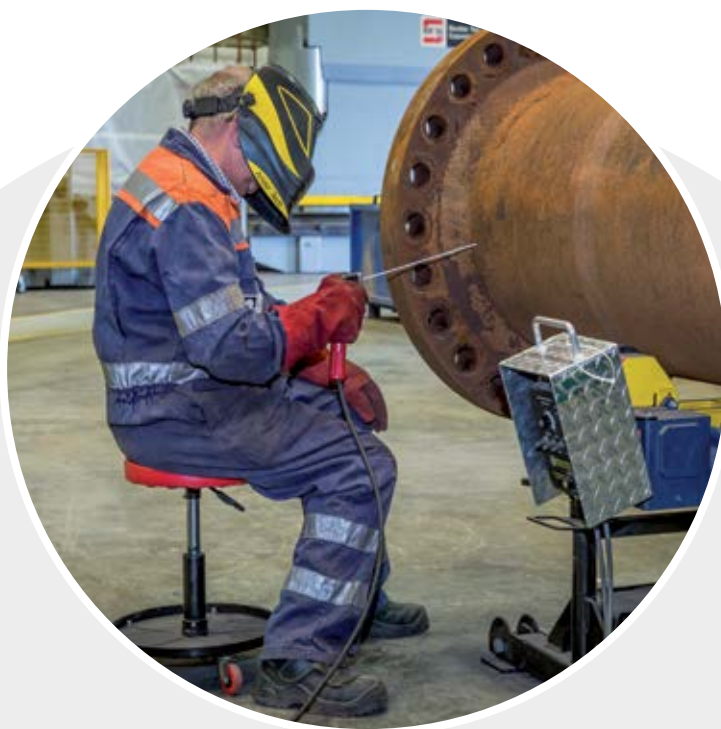
After: The use of the new roller system allows operators to alternate posture from standing to sitting during welding.

- One welder can now complete the task in a single standing position and does not have to crouch or be exposed to potential burns from overhand welding.
- Welders have posture improvements.

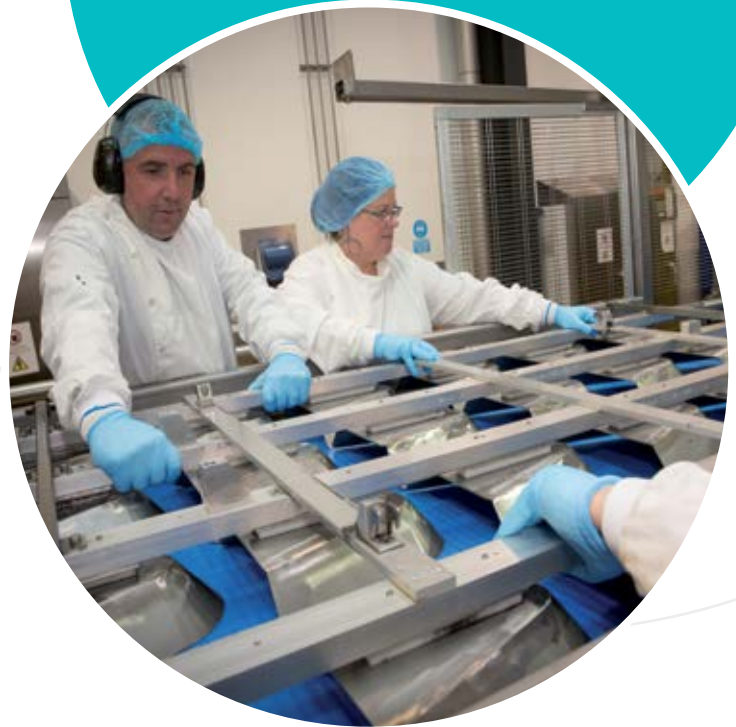
Before: Team lift by three operatives to transfer Positioner Head

- Positioner Head Load weight too heavy (between 45kg and 55kg).
- Load too bulky
- Load lifted above shoulder height

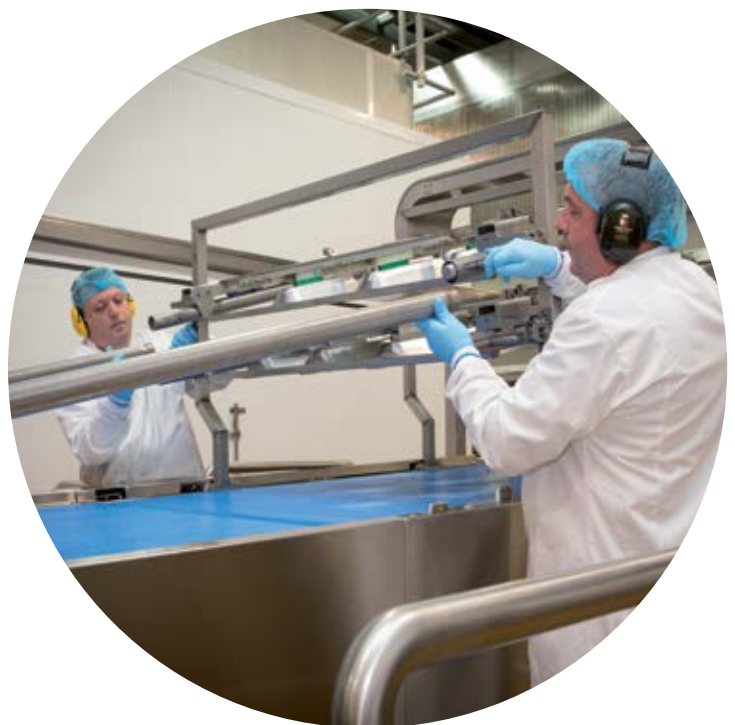
After: Two Operatives changing Positioner Head

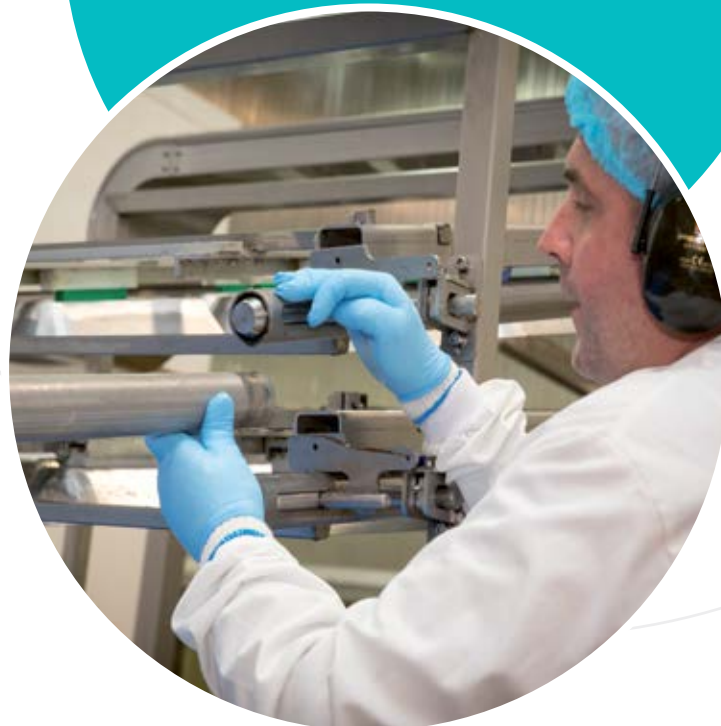
**After: Operative Releases Clips to Allow the Transfer of the Positioner Head**

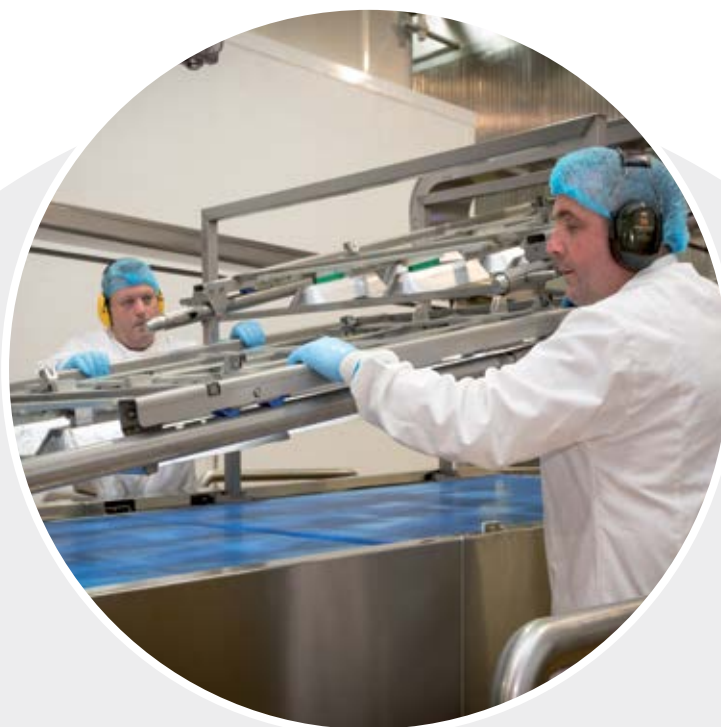
**After: Rolling System allows Positioner Head to roll onto the line**

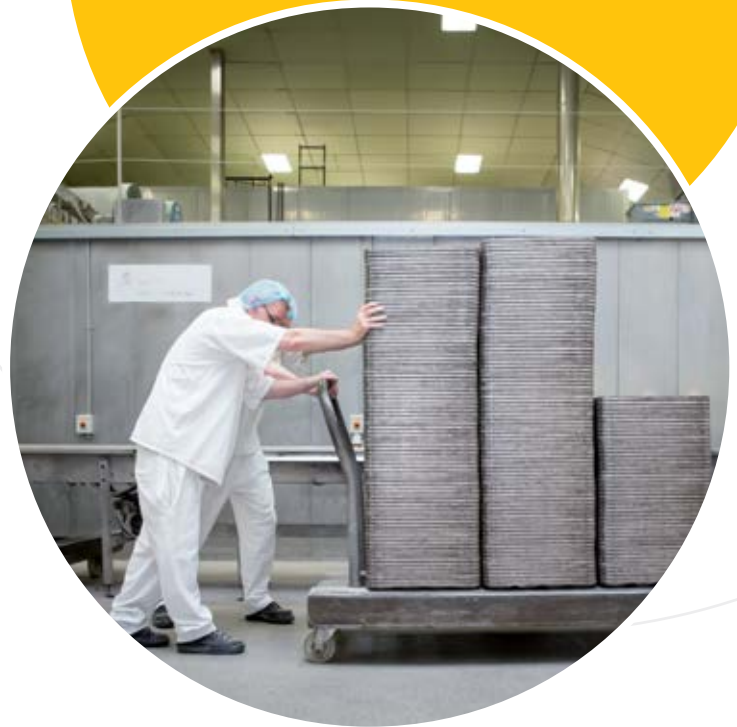
Before: Two Operatives push heavy buggy containing baking trays

- The physical effort of pushing heavy buggies is too strenuous
- Large lifting force required to move buggies into position
- Awkward postures required during the positioning of the buggy
- The load weight (i.e. buggy with baking trays) is too heavy
- Lack of access in the work environment to move the buggy safely

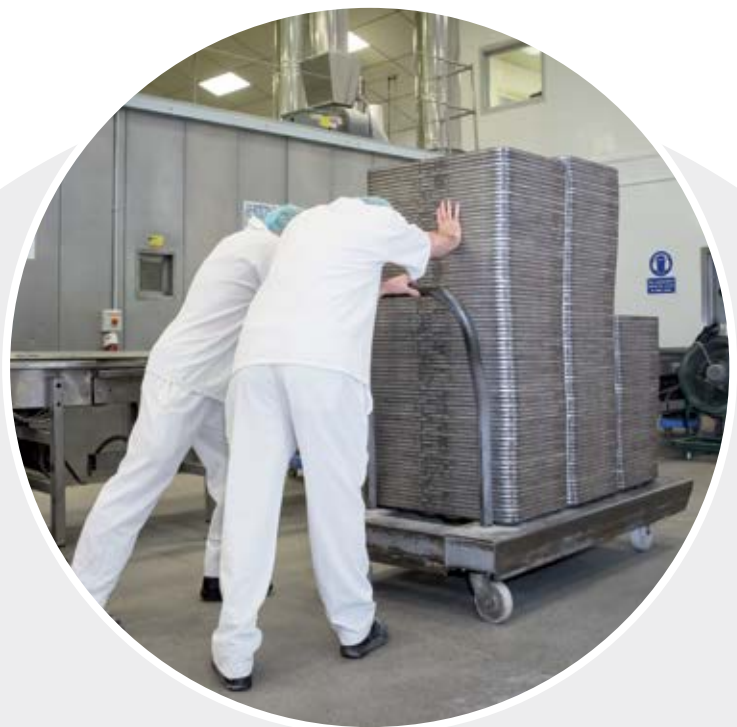
Before: Two Operatives push heavy buggy containing baking trays

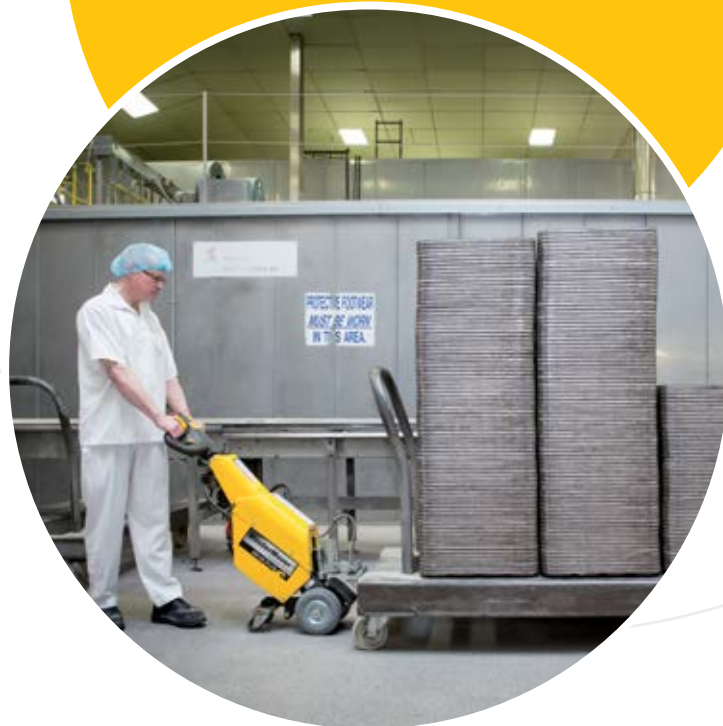
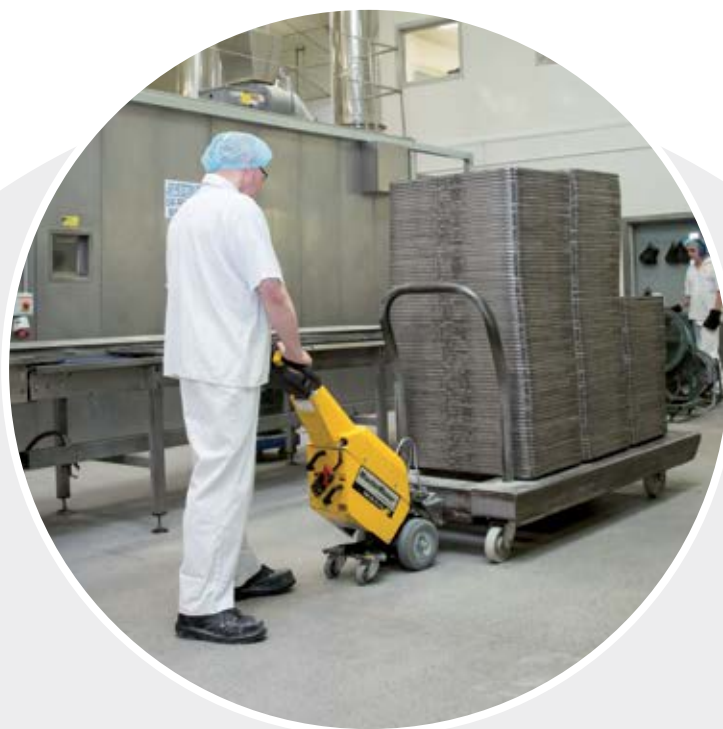
After: The two images show a single operative moving the trays using a tug on the buggy

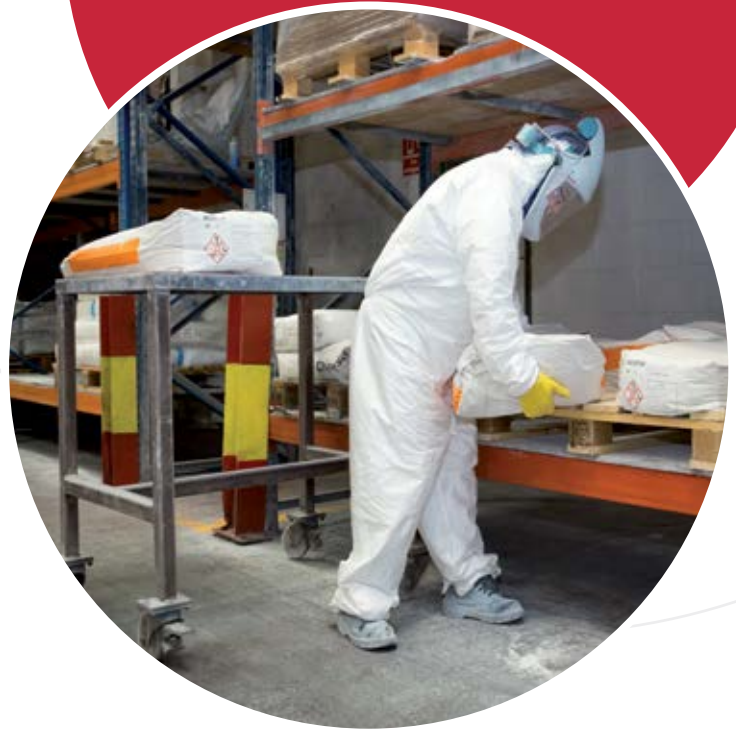
Before: Operative lifts bag manually from a storage location in the pre-mix areas and places it onto a trolley

- Lifting above shoulder height and below knee height
- Awkward posture when lifting away from the body
- Load weight too heavy (25 kg)
- Physical activity too strenuous

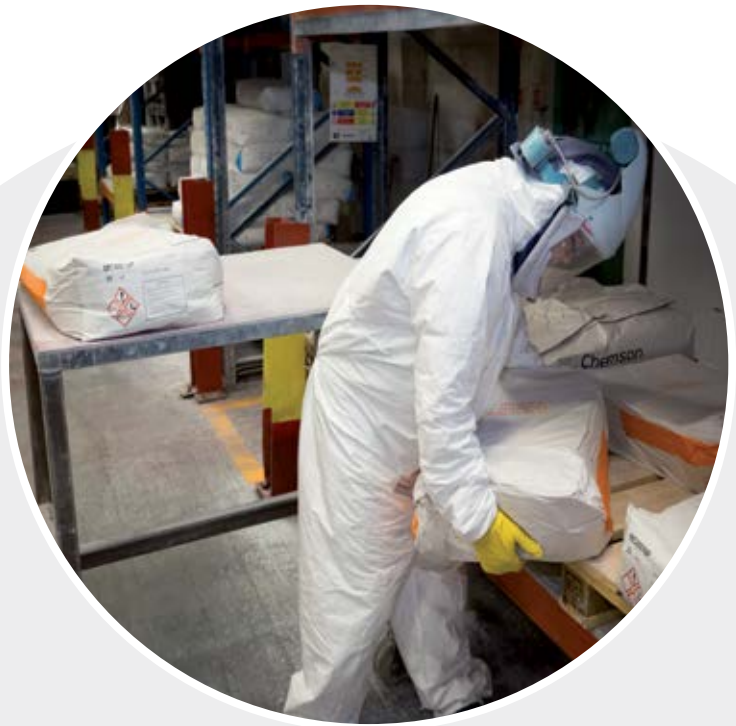
Before: Operative lifts bag and places it onto a trolley and then lifts bag from the trolley into a weigh station

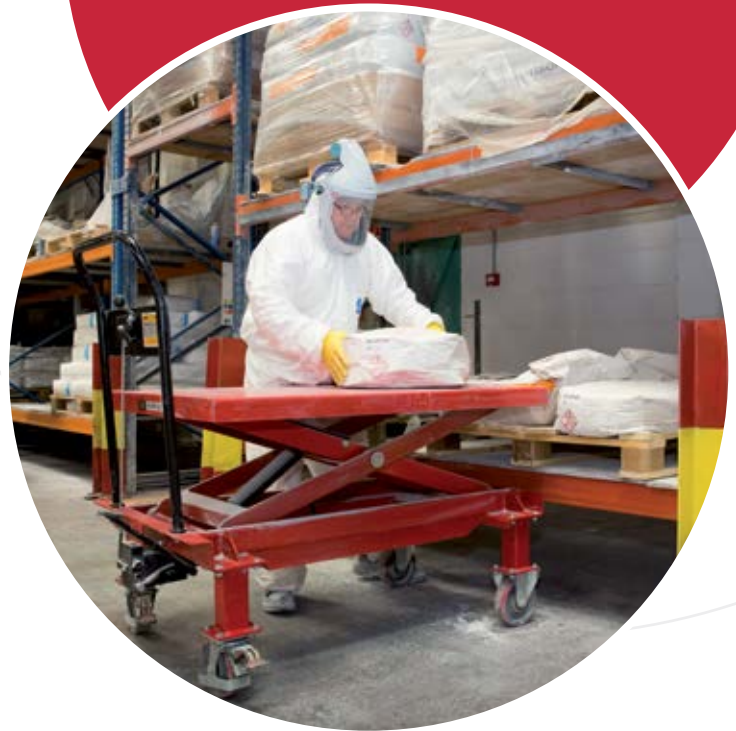
After: Operative slides bag onto a scissors lift table

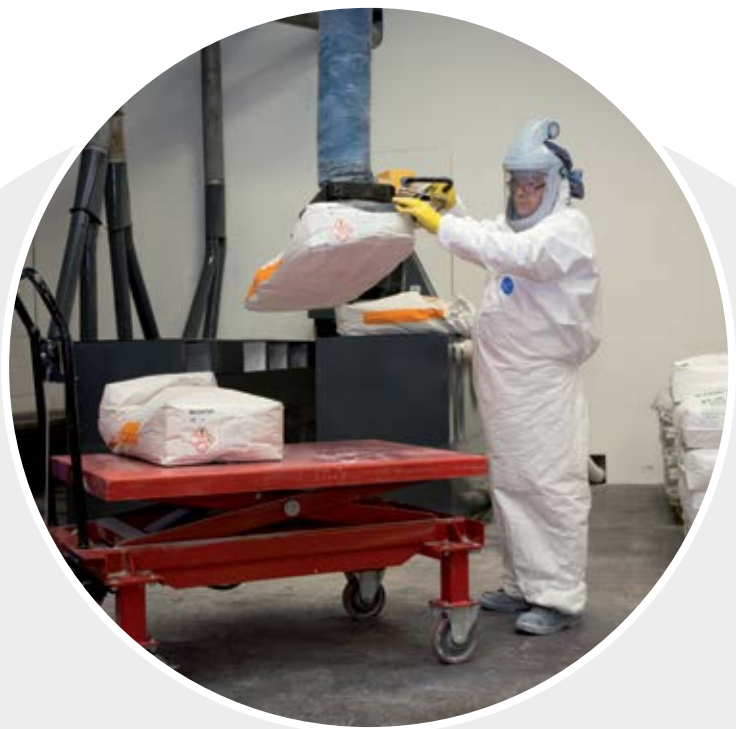
After: Operative uses a power vacuum lifter to move bag
