## Ergonomics Good Practice Case Study

### **Construction Sector**

JJ Rhatigan & Company

A new office building was being constructed in Galway City; the building design specified that large stone cladding units were to be installed and fitted to the facade of the building. The stone cladding units were large and heavy, varying from 19.4kg to 143.7kg. A specialist sub-contractor was procured by the company Project Supervisor Construction Stage (PSCS) to install the stone cladding units on site. The sub-contractors initial proposed system of work was based on the long-established traditional methods of manual transfer of each stone cladding unit from a pallet on the loading bay onto a trolley and then a two-person manual lift (and hold) during the final placement of stone cladding in the building's facade.

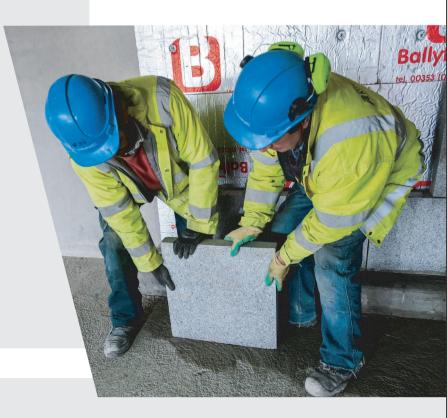
- ☐ Awkward posture while holding the stone cladding unit in position at the building façade
- ☐ The weight of the stone cladding units (up to144kg load weight) and the upper arms are angled away from the body and the trunk is bent forward
- Twisting postures while manoeuvring and aligning the stone cladding units prior to installation
- ☐ Lifting heavy stone cladding units from the trolley/scaffold up to chest height

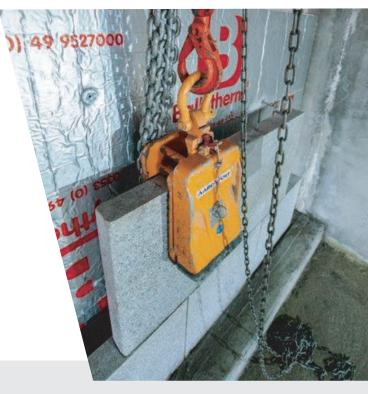
A bespoke certified mild steel cantilever bracket was manufactured and hung from the top of the wall and secured into position. A chain block was then attached to the cantilever bracket with a certified D-Shackle connection and the Lifter/Grab was then attached to the chain block using designated attachment points. The cantilever bracket was moved horizontally along the top of the wall as the stone cladding progressed.

The introduction of the chain block and Lifter/Grab eliminated the manual lifting of very heavy stone cladding units and avoided the need for sustained awkward bending and twisting postures that resulted from the manual installation process.
